April 13, 2023

Toupie Rooney
Code Enforcement Officer
Town of Northport
16 Beech Hill Road
Northport, ME 04849

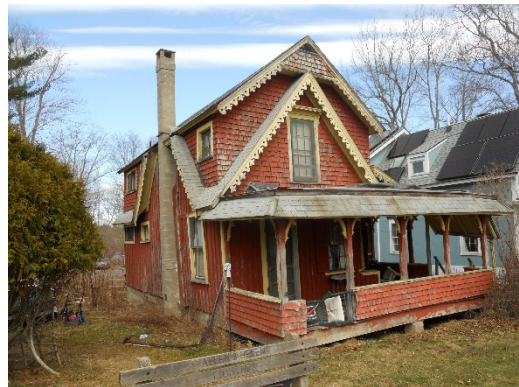
- The rear/north addition has a chimney which is visible above the roof, but does not continue down to the foundation. It is surmised that the masonry chimney bears on the addition floor framing which is combustible (wood).
- The chimney on the west exterior wall is in disrepair. Spalling and cracks are visible.
- The wastewater line is disconnected under the front porch, suggesting the home has been abandoned for some time; or if occupied, has been depositing wastewater directly into the ground under the front porch.
- The building has not been maintained, is dilapidated and is in the process of slowly collapsing.
- Exterior trim and finishes are degraded.
- Some windows are broken, leaving the building open to weather.

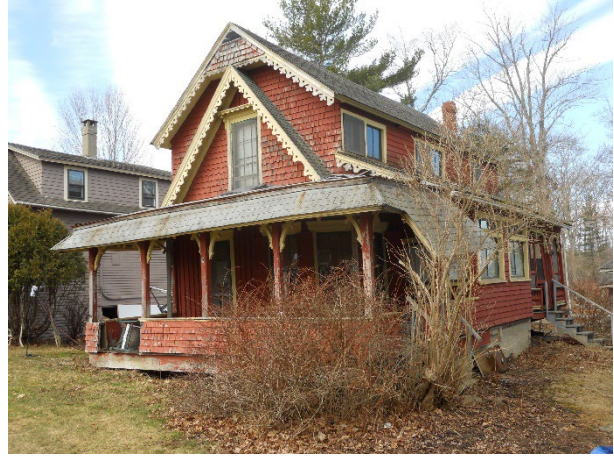
2) Exterior – South/east façades; south/front porch; extended overhanging entry porch roof is failing; porch is structurally unsound

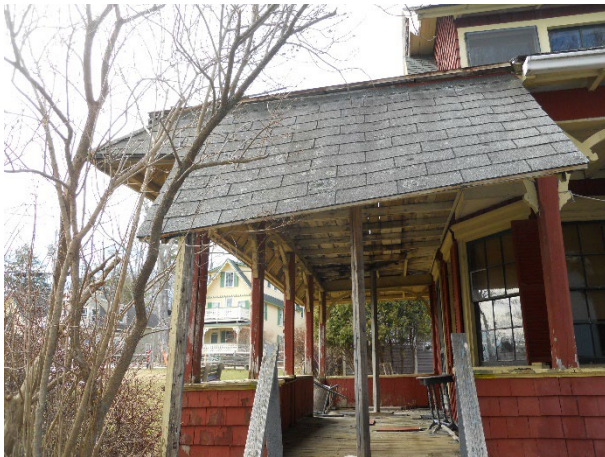
3) Exterior – South/front porch extended overhanging entry porch roof is failing

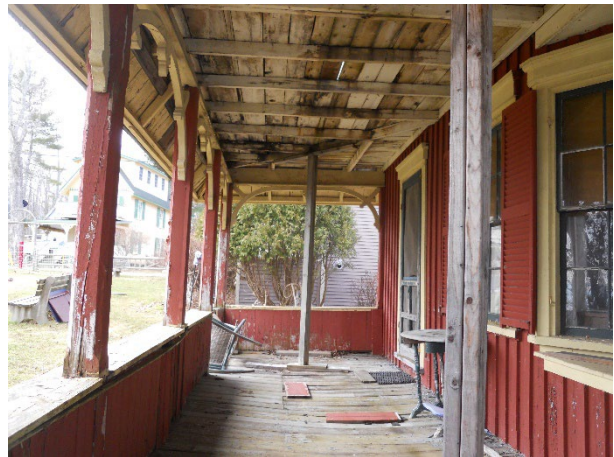
4) Exterior – South/front porch roof and floor are structurally unsound

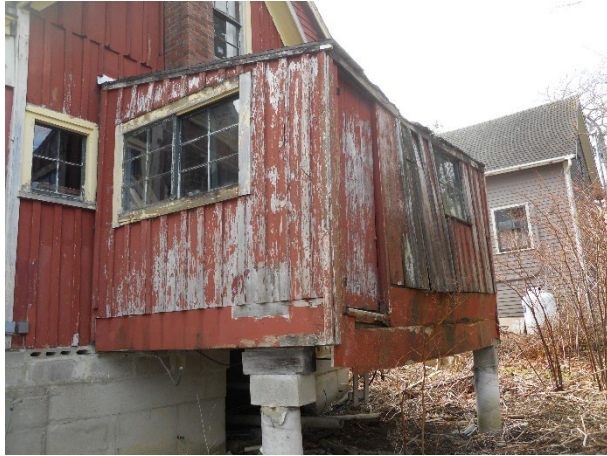
7) Exterior – North addition is degraded and appears structurally unsound

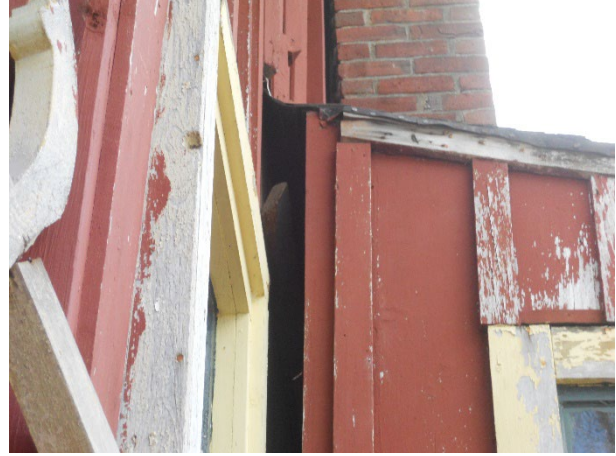
8) Exterior – North addition is separating from the main house; the chimney visible above the addition roof bears on combustible framing

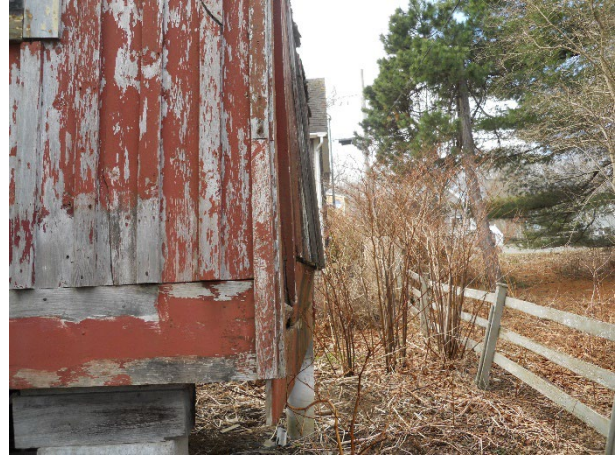
10) Exterior – North addition has significant bulges in the exterior walls, suggesting structural failure in the wood framed walls

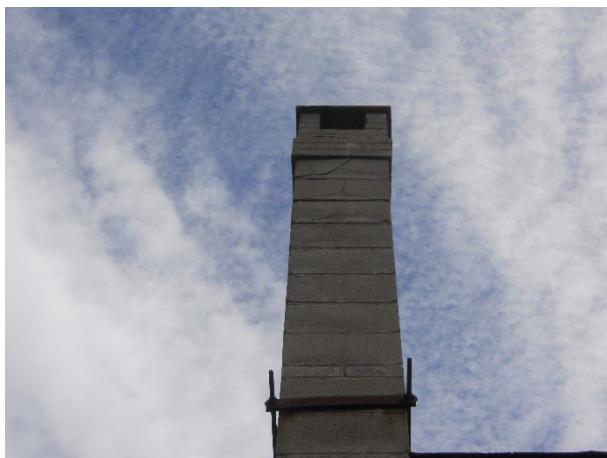
11) Exterior – West CMU chimney has significant cracks and may be unstable above the roof line

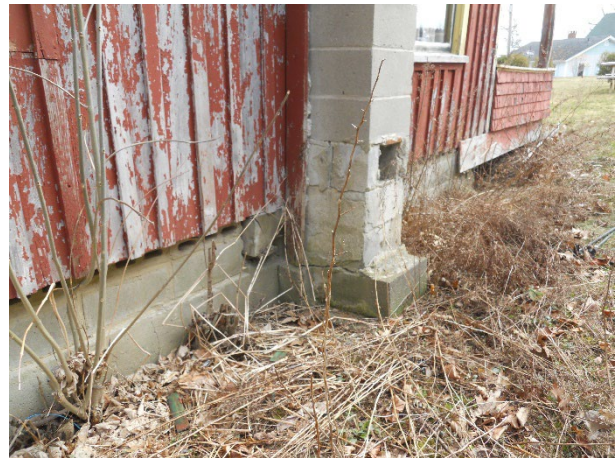
12) Exterior – West CMU chimney has significant cracks and spalling at the base

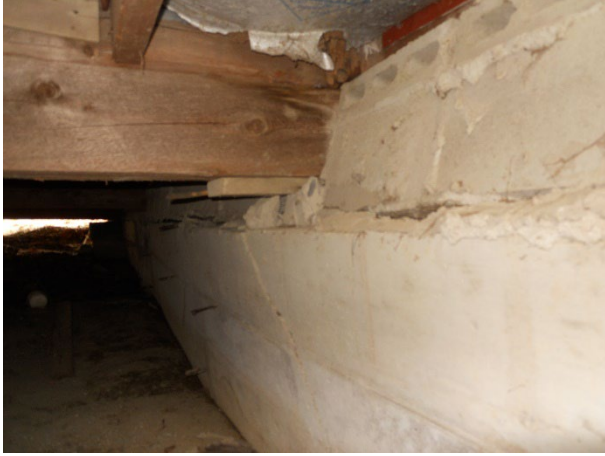
13) Foundation – CMU block courses are tipping, rotating and otherwise failing; large cracks and displaced blocks are present

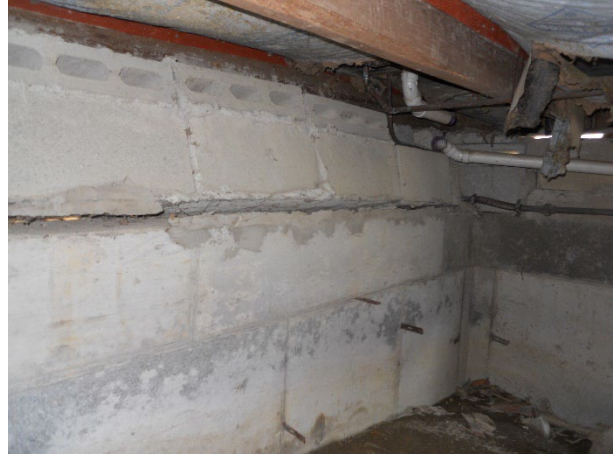
14) Foundation – CMU block courses are tipping, rotating and otherwise failing; large cracks and displaced blocks are present

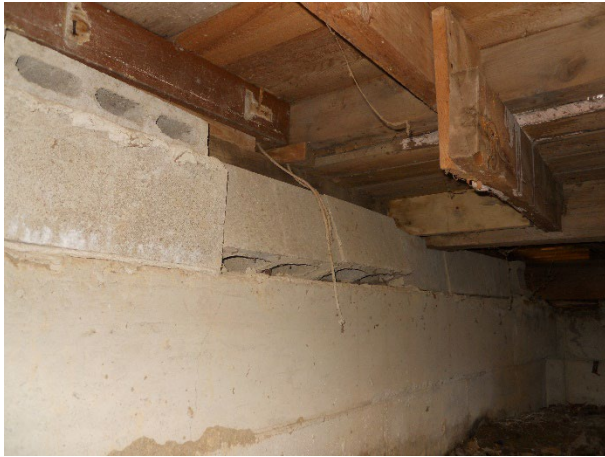
15) Foundation – CMU block courses are tipping, rotating and otherwise failing; large cracks and displaced blocks are present

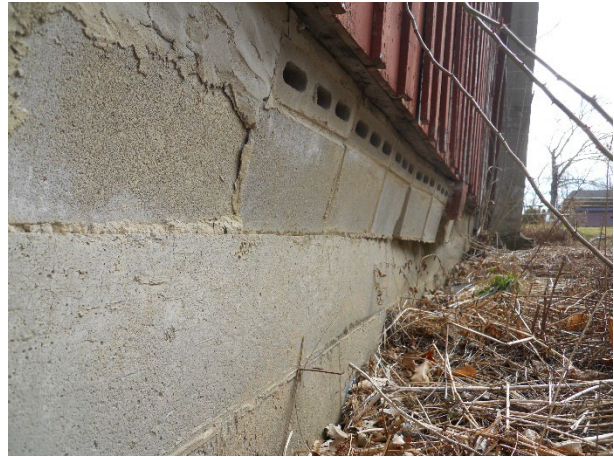
16) Foundation – CMU block courses are tipping, rotating and otherwise failing; large cracks and displaced blocks are present

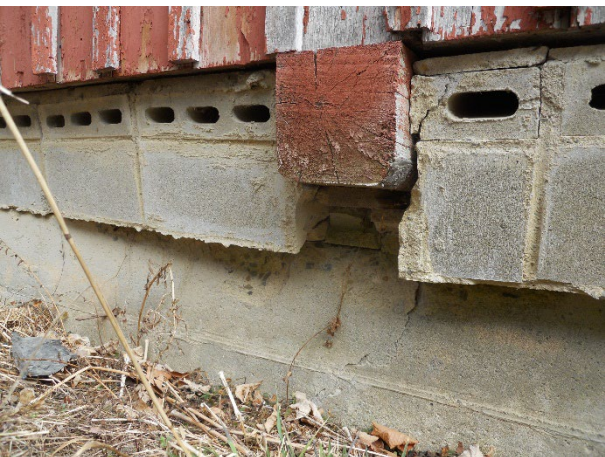
17) Foundation – CMU block courses are tipping, rotating and otherwise failing; large cracks and displaced blocks are present

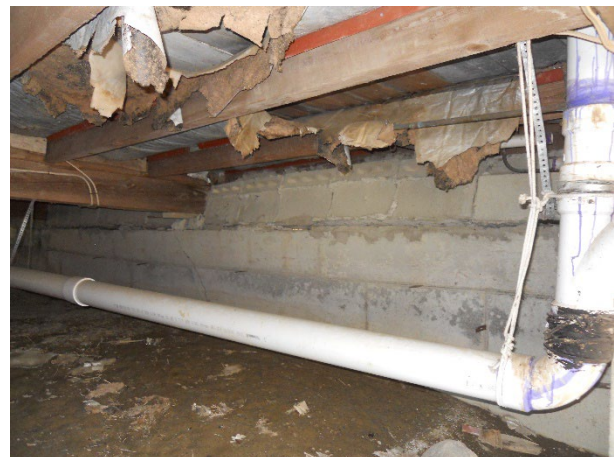
18) Utilities – Main wastewater line runs southerly from north addition to south/front porch where it is disconnected and ends on the ground
