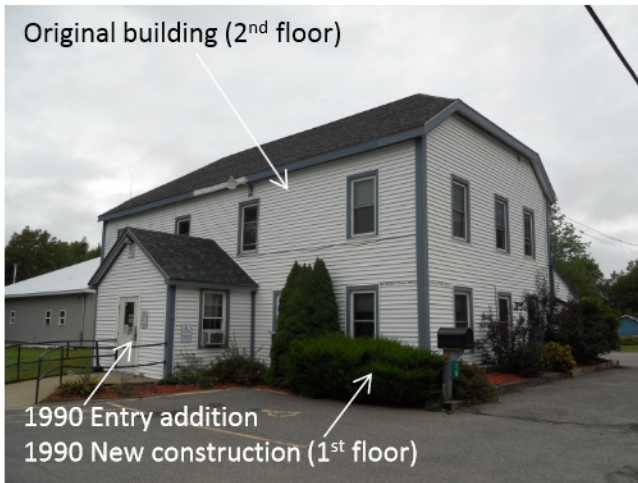
1) Exterior – West (left) and south (right) facades; original 1-story school house building was lifted and added on to in 1990

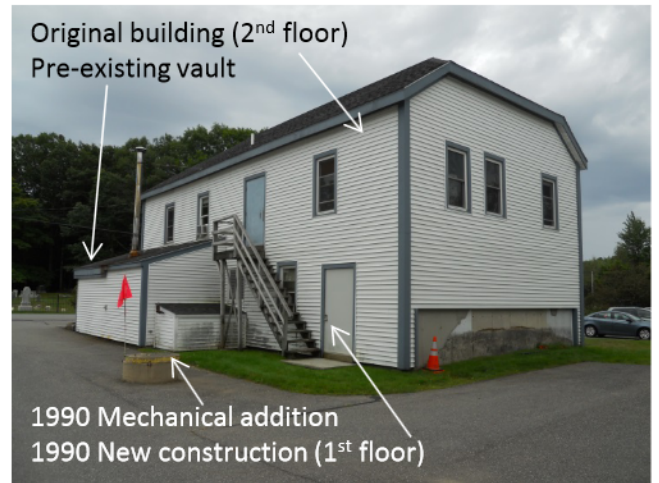
2) Exterior – East (left) and north (right) facades; original 1-story school house building was lifted and added on to in 1990

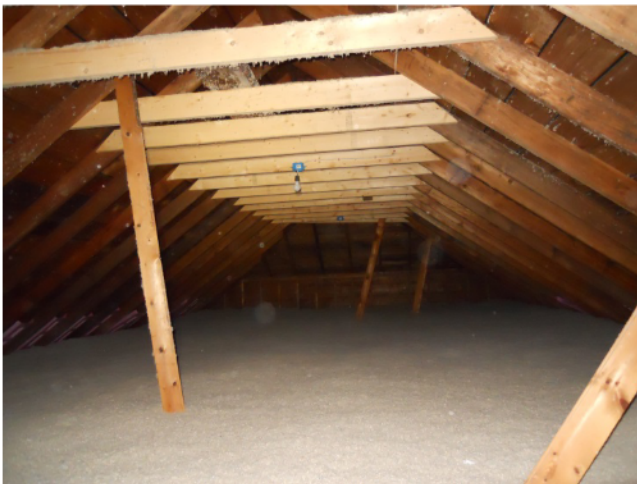
3) Roof framing – Original rafters (darker) remain; 2x6 collar ties were added to stiffen and reinforce original roof assembly

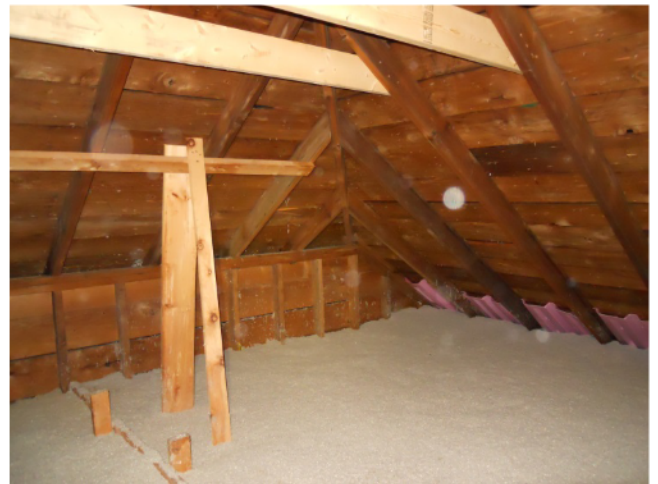
4) Roof framing – Raised south endwall with hip rafters at corner; rafter vents are present along east and west eaves due to thick insulation

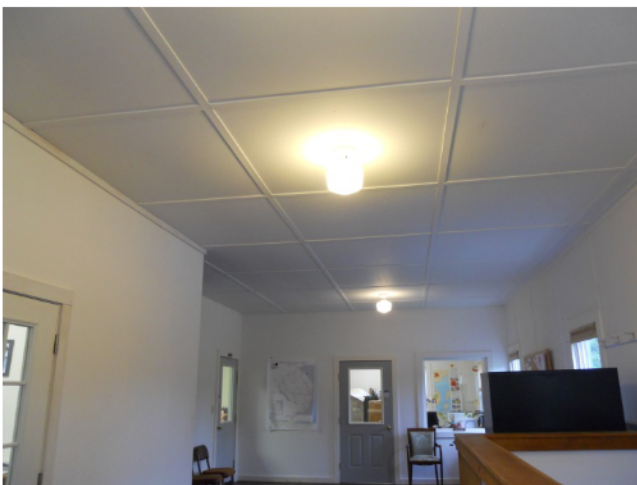
5) Ceiling framing – Ceiling joists require intermediate support; some spans exceed the capacity of the existing ceiling joists

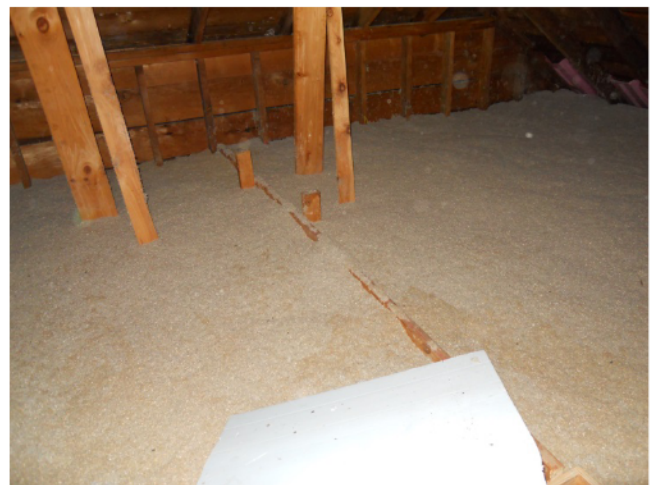
6) Ceiling framing – Ceiling joists require intermediate support; haphazard verticals provide additional support in some locations

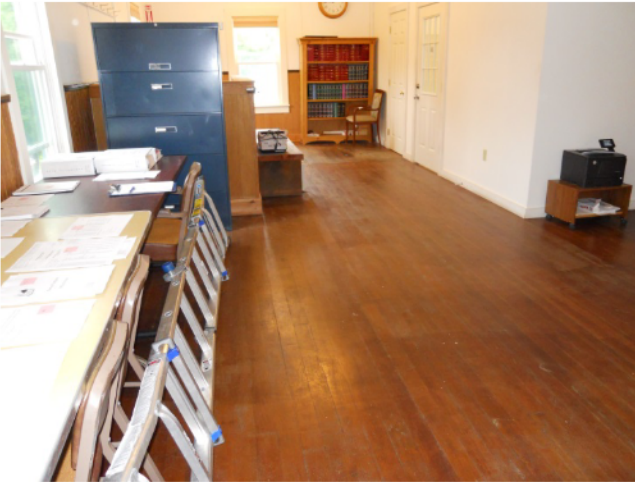
7) Second floor – Use of second floor impacts structural loading criteria; public lobby/corridors have higher load requirements than offices

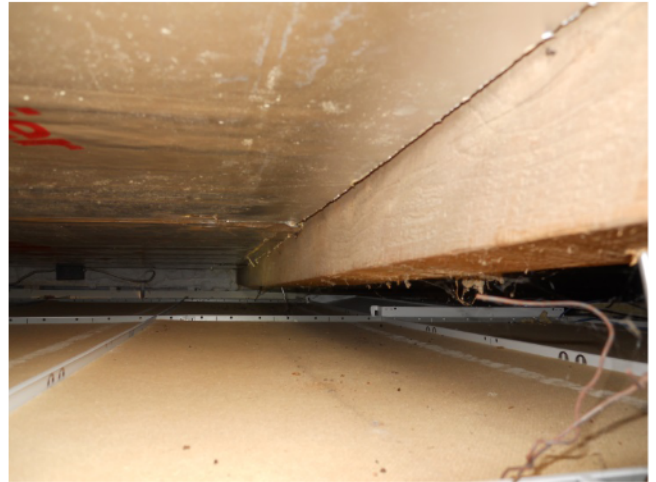
8) Second floor framing – Existing dropped 6x6 beams are severely deficient (beams are partially hidden by rigid insulation and strapping)

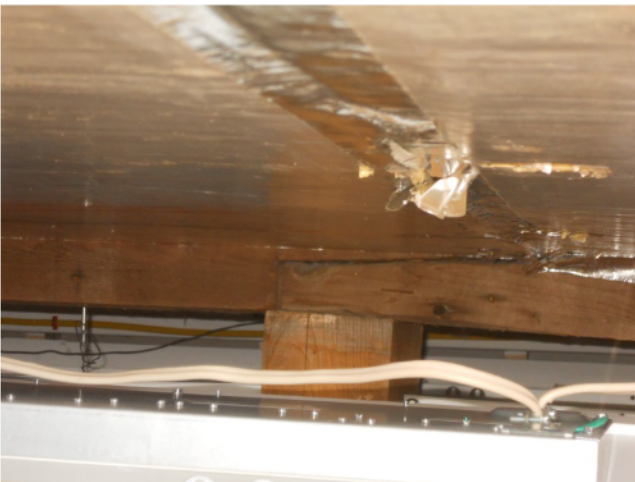
9) Second floor framing – Existing dropped 6x6 beams are severely deficient; beams are spliced at post locations

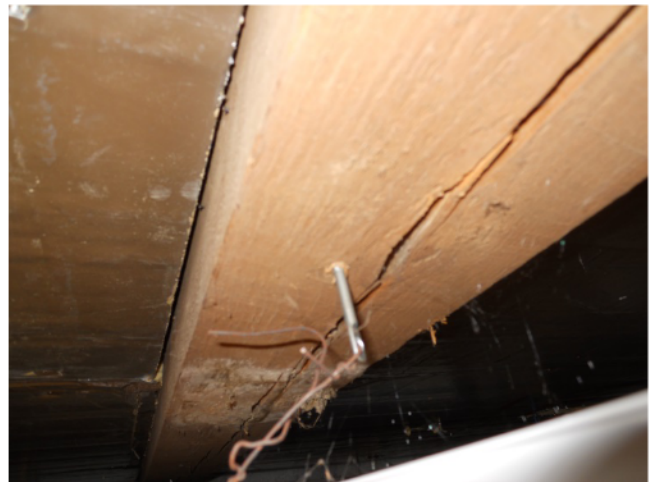
10) Second floor framing – Existing dropped 6x6 beams are severely deficient; beam cracks are likely structural

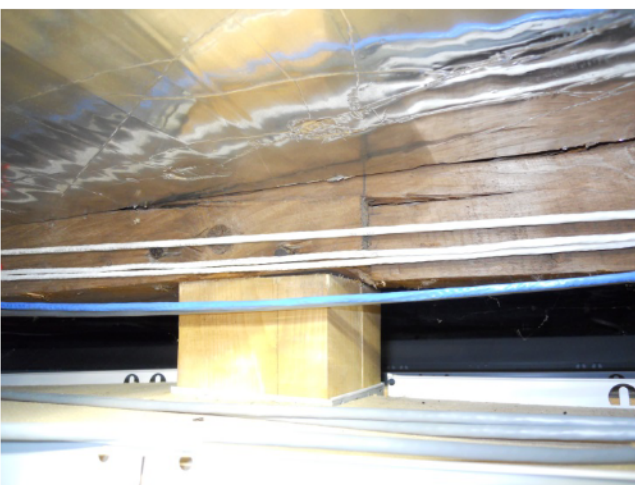
11) Second floor framing – Existing dropped 6x6 beams are severely deficient; cracked beam near southeast post is structurally compromised

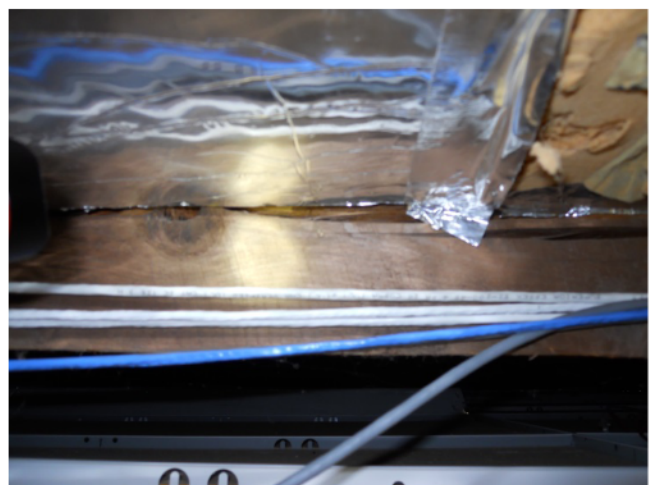
12) Second floor framing – Close-up of cracked beam near southeast post

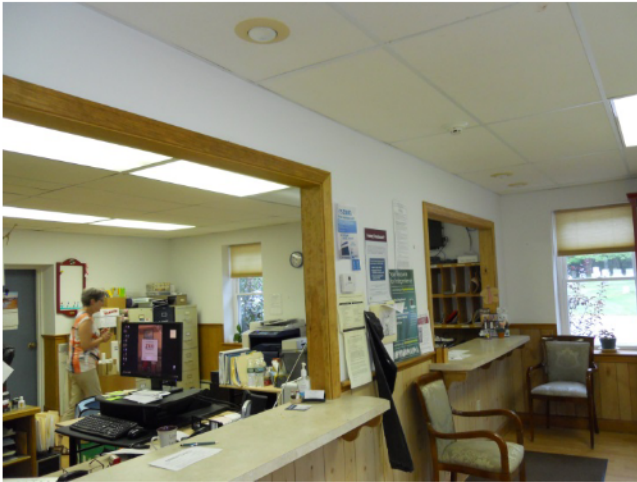
13) Second floor supports – Original post location is at window; interior wall is likely acting as an inadvertent bearing wall

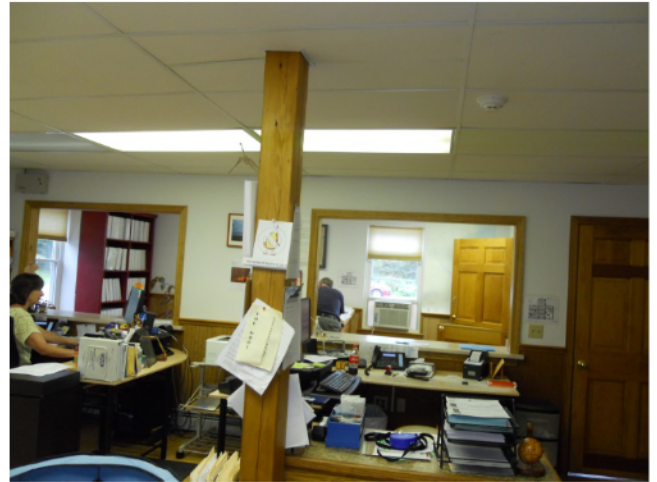
14) Second floor supports – Southeast post (foreground); beams and posts supporting second floor are recommended for replacement

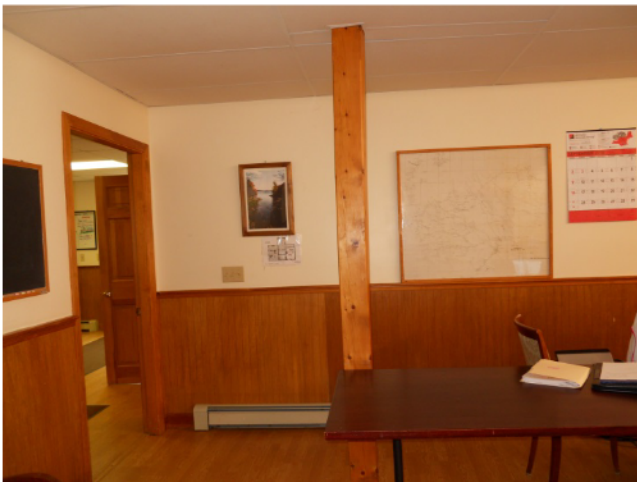
15) Second floor supports – Northwest post in meeting room is severely bowed, skewed and moderately checked; replacement required

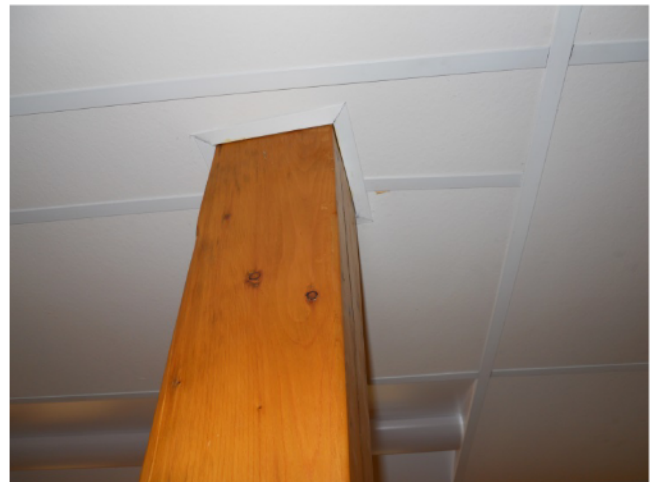
16) Second floor supports – Northwest post in meeting room is severely bowed, skewed and moderately checked; replacement required

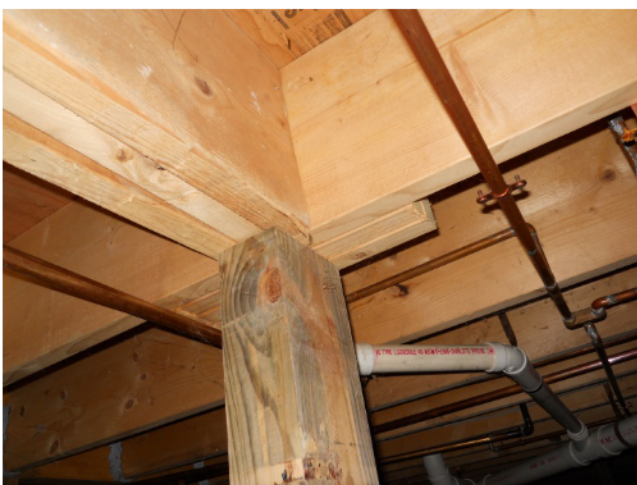
17) Second floor supports – Some posts in the crawl space appear to be aligned with posts supporting the second floor above

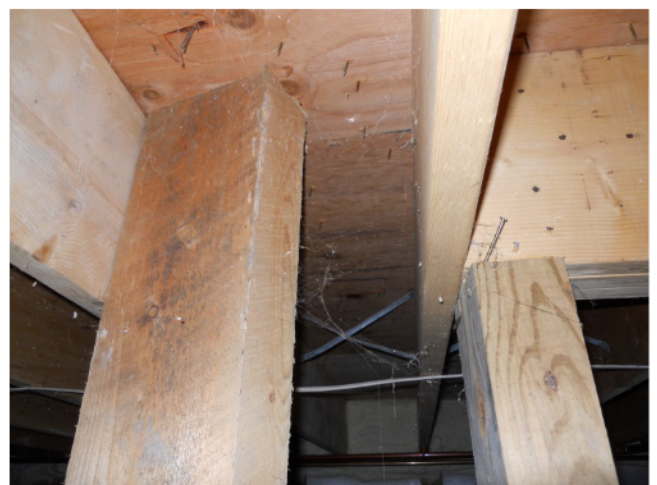
18) Second floor supports – Some posts in the crawl space may not be properly aligned with posts supporting the second floor above

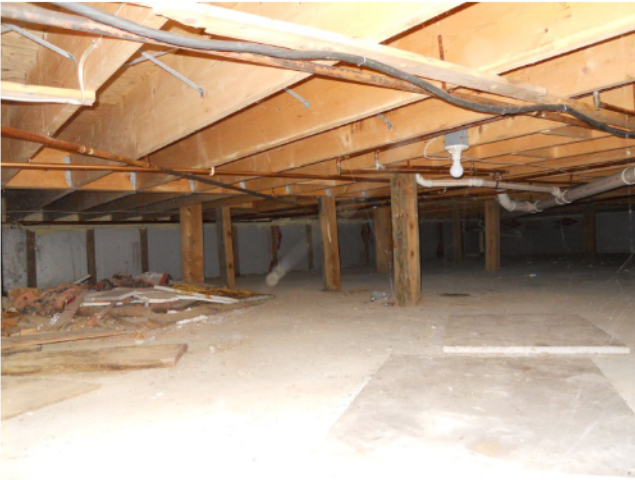
19) First floor framing – Typical framing is 2x12s at 16" o.c. spanning from exterior foundation wall to center support beam

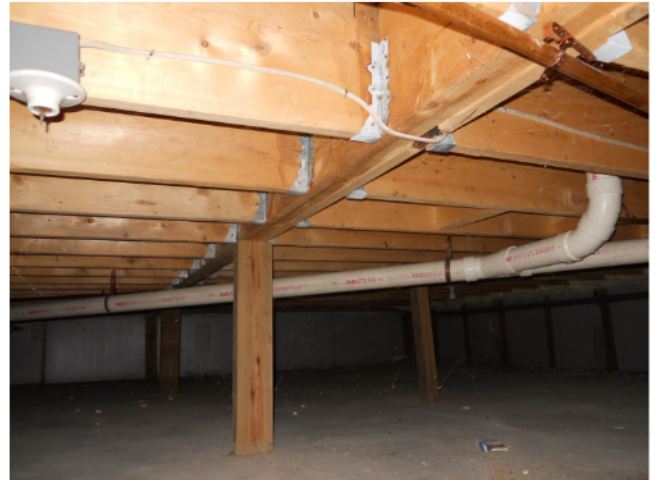
20) First floor framing – (3) 2x12 center support beam; beams is lapped and spliced; 4x6 PT support posts are spaced approximately 8' o.c.

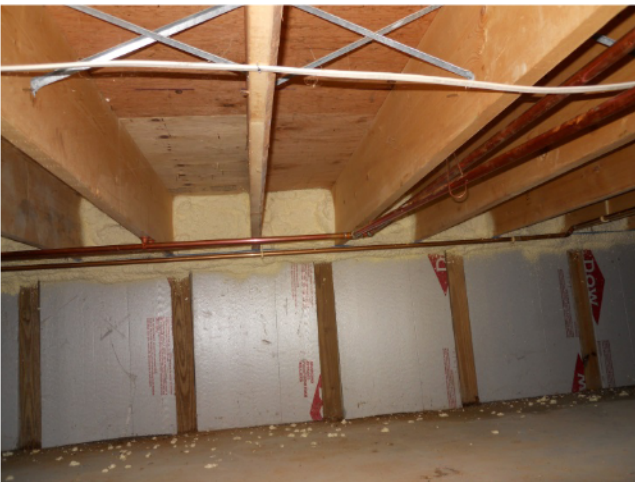
21) First floor framing – Framing at foundation wall is attached to ledger which is supported by flatwise 2x4s; rigid insulation obscures foundation

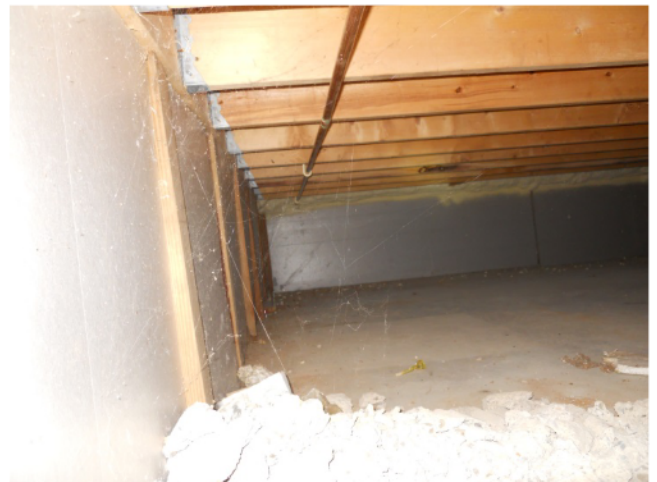
22) First floor framing – Framing at foundation wall is attached to ledger which is supported by flatwise 2x4s; rigid insulation obscures foundation

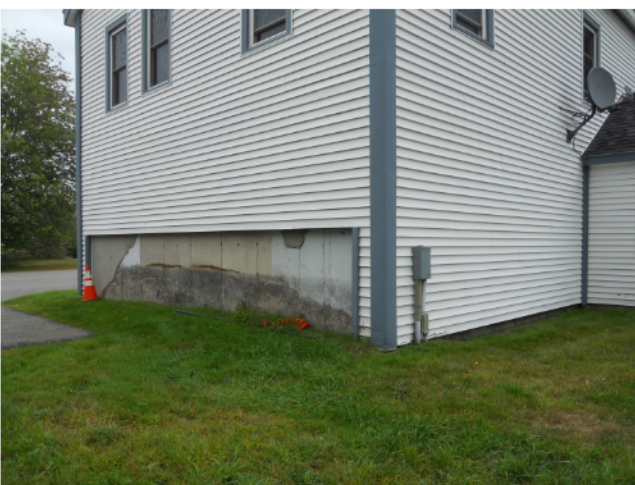
23) Foundation – North foundation; grades have been lowered on exterior; wall is bowed inward and has been previously repaired

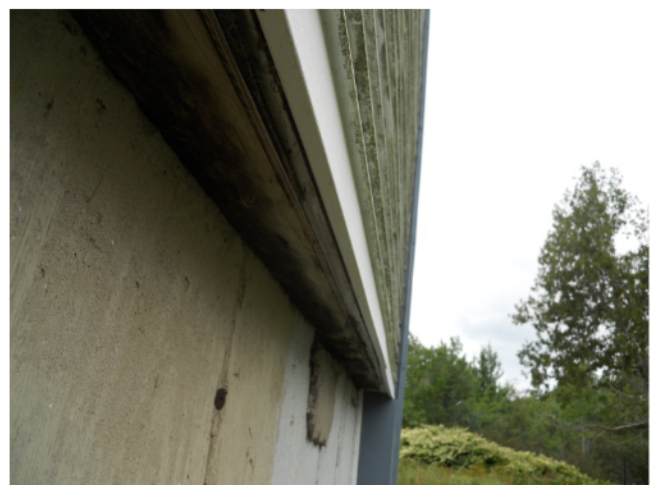
24) Foundation – North foundation; wall is significantly bowed inward

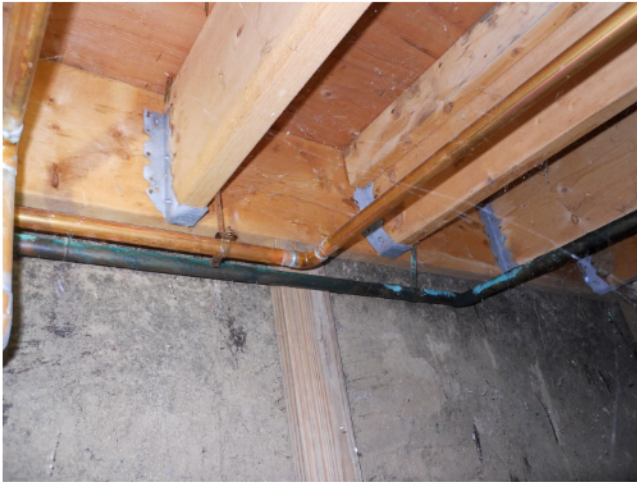
25) Mechanical room – Framing at mechanical room is sturdy, but ledger attachment is marginal

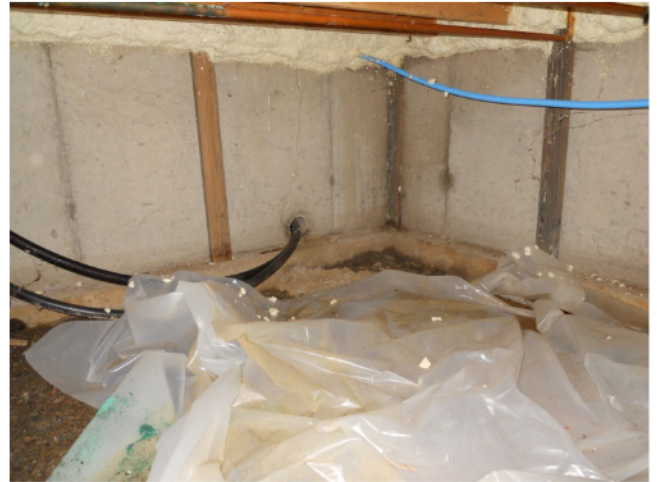
26) Mechanical room – Moisture from dirt floor should be mitigated

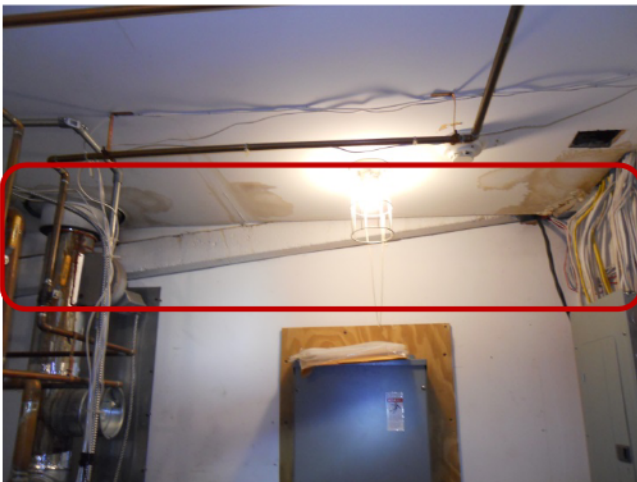
27) Vault roof/ceiling – Edge of vault roof is exposed concrete; mechanical room roof framing is not exposed

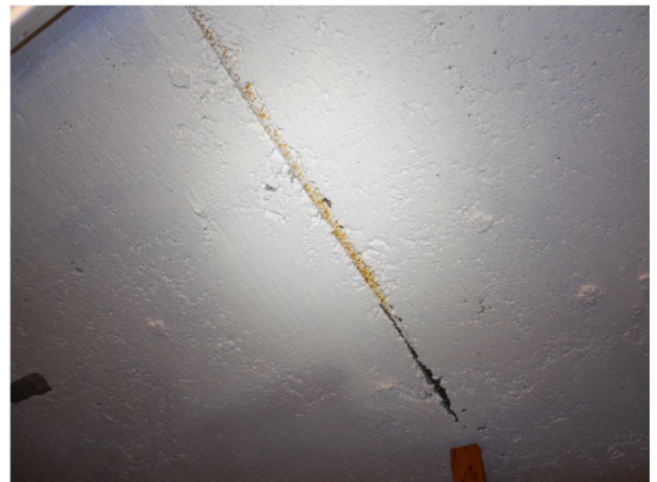
28) Vault roof/ceiling – Poorly consolidated concrete is present; rebar is exposed on underside (inadequate concrete cover)

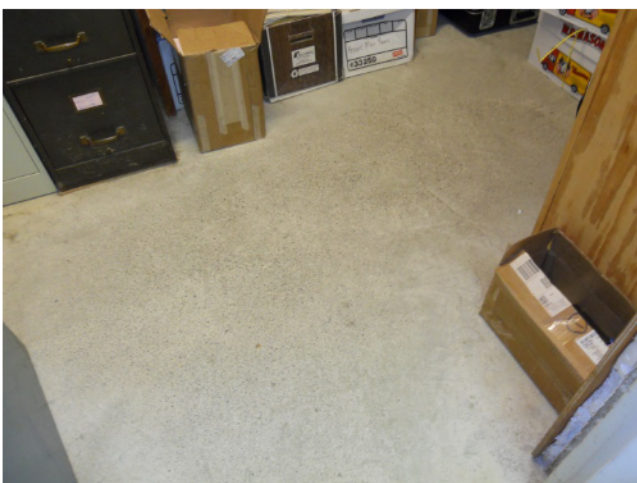
29) Vault slab – Vault slab-on-grade appears to be in satisfactory condition

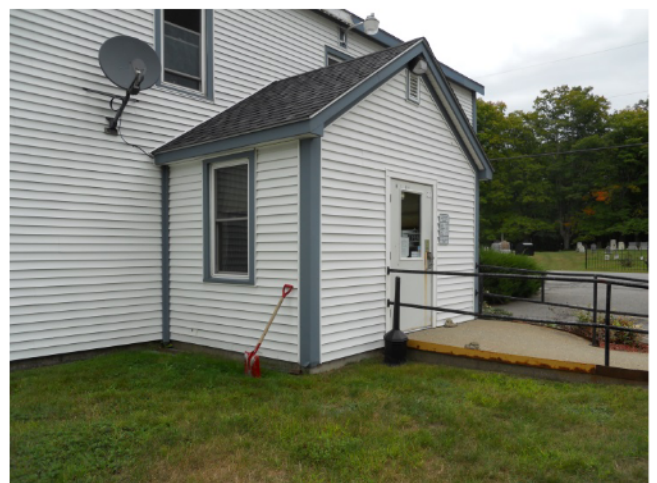
30) West addition – Neither the roof framing nor the slab on grade were exposed for observation

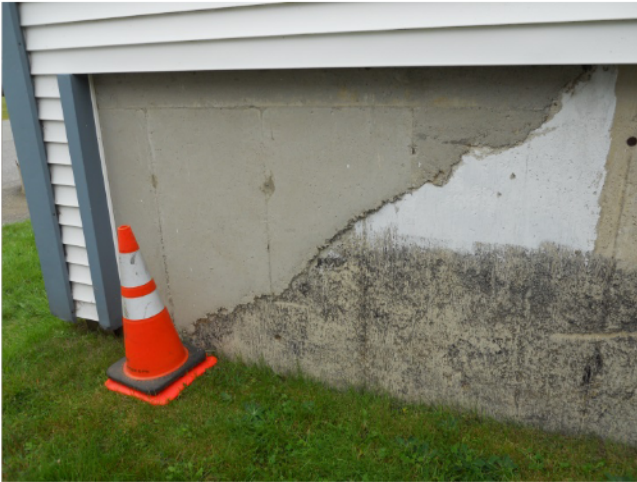
31) Exterior – Foundation repairs are evident; panel forms indicate more recent construction than 1932

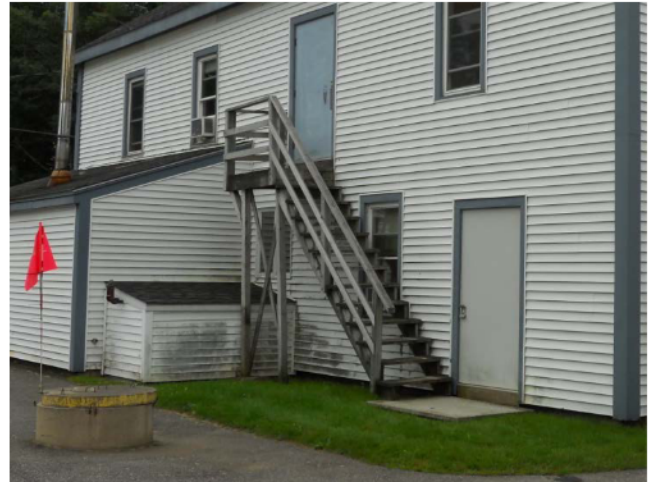
32) Exterior – Egress stairs and landing are structurally deficient; replacement recommended

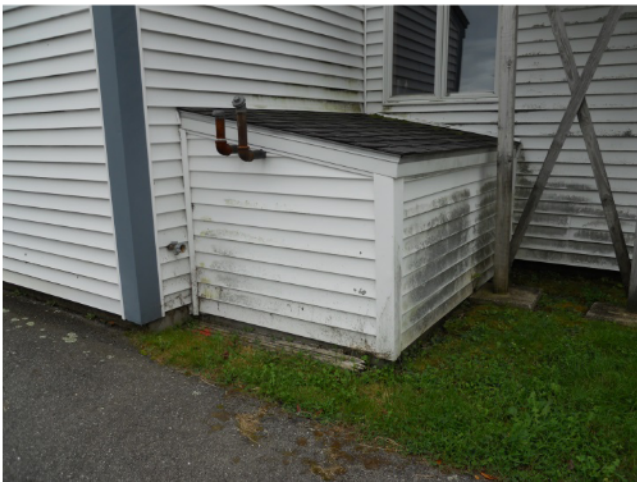
33) Exterior – Fuel storage enclosure construction not exposed for observation

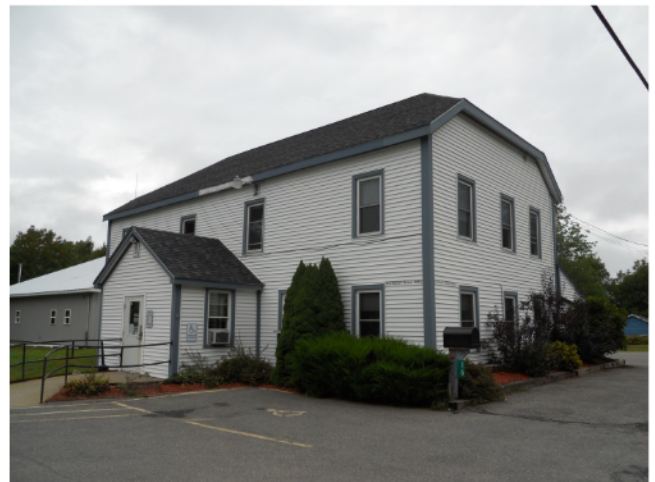
34) Exterior – Plantings adjacent to structure increase presence of moisture

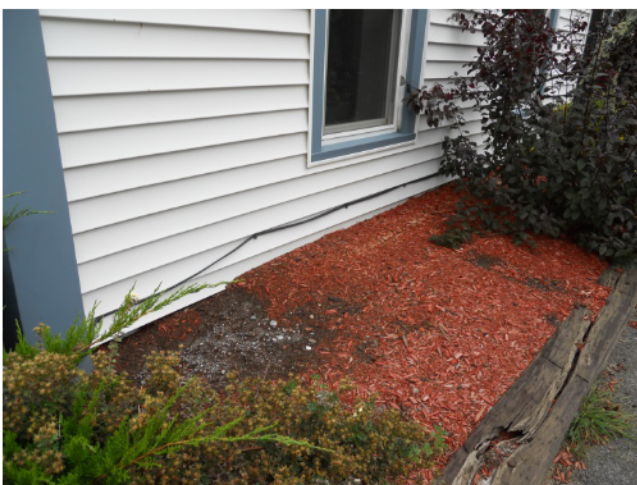
35) Exterior – Raised beds against the structure increase the presence of moisture; lower beds and regrade to slope away from the building

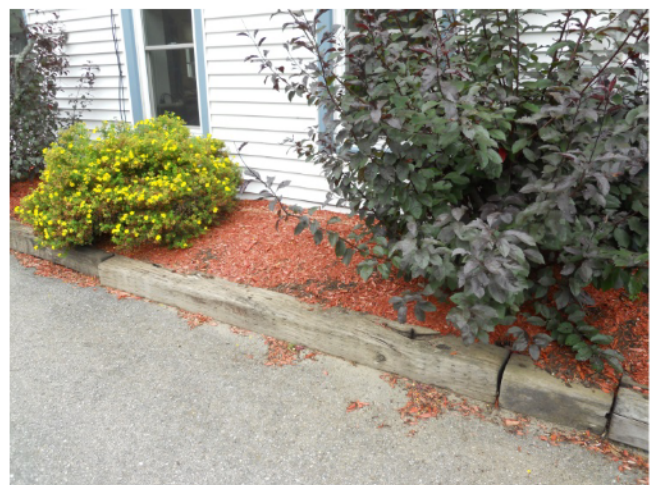
36) Exterior – Raised beds against the structure increase the presence of moisture; lower beds and regrade to slope away from the building
